Preferred Schematic Report  
Agawam High School

Re: **Preliminary Geotechnical Report  
Proposed Agawam High School  
Agawam, Massachusetts  
LGCI Project No. 2327**

Existing Conditions Report – Site/Landscape

## CIVIL EXISTING CONDITIONS ASSESSMENT NARRATIVE

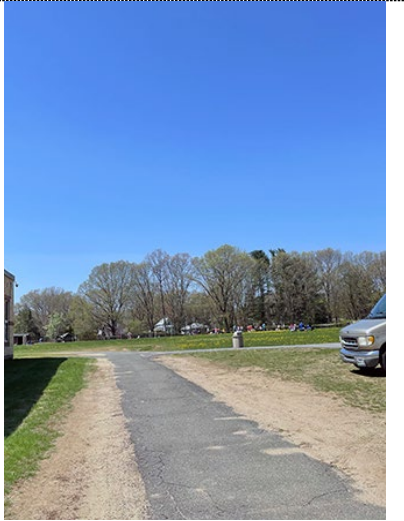
Specific Issues	Recommendations	Photos
<p>It appears that vehicular travel and snow push around the narrow, discontinuous, and curb-less asphalt access loop leads to turf damage.</p>	<p>Reconstruct a wider, curbed access loop around the school building with designated snow storage areas to allow passage of service vehicles and removal of snow while maintaining turf integrity.</p> <p><i>Image: Vehicular damage of turf surrounding asphalt access loop.</i></p>

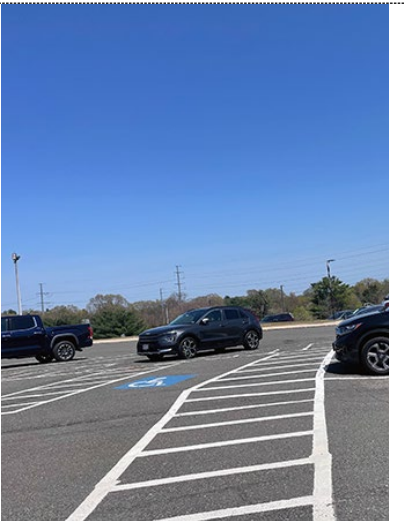
<p>The three main parking areas on the school campus may not meet ADA and MAAB requirements for the provision of safe, accessible parking spaces.</p>	<p>Add additional accessible parking spaces wherever they are lacking, following ADA and MAAB requirements. Ensure infrastructure is present to protect access aisles.</p> <p><i>Image: Accessible faculty parking lacking the protection of access aisles.</i></p>

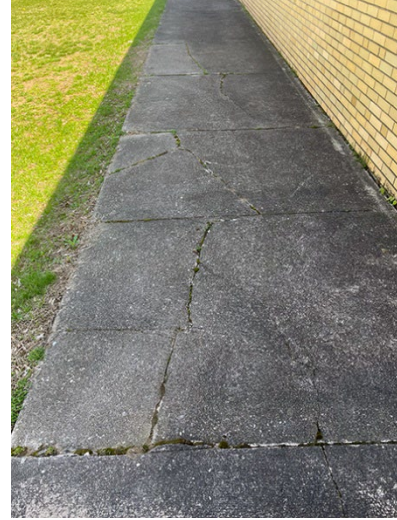
Pedestrian pavements are in various stages of decline and in some instances appear to be non-compliant with ADA and MAAB requirements due to uneven surfaces and steep slopes, or a failure to connect to site amenities.

*Image: Pedestrian pavement adjacent to the school building with numerous cracks.*

It is recommended that walkways be repaired or replaced to remedy damage that creates uneven surfaces and reduces safety and accessibility. It is further recommended that all steep walkways be investigated for compliance with ADA and MAAB requirements. Accessible walkways should allow access to amenities throughout the site.

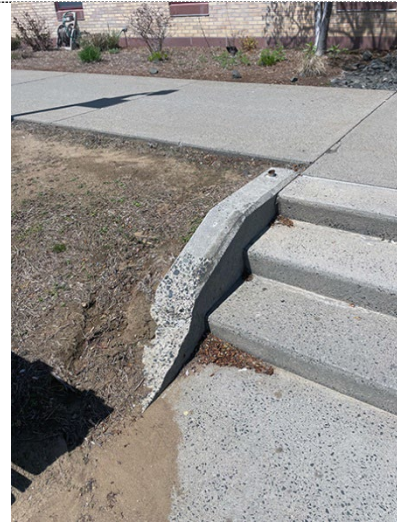
Several stairs and ramps are in poor condition, with cracking and crumbling observed. Stair and ramp handrails in some instances are missing or non-compliant, lacking the required extensions per ADA and MAAB codes.

*Image: Stair leading to the front entrance with broken cheek wall and missing handrail.*

It is recommended that all pedestrian stairs and ramps in disrepair be reconstructed and outfitted with ADA and MAAB-compliant handrails.

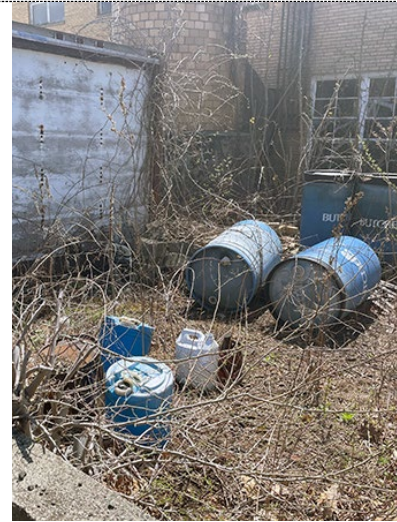
The utility and maintenance-oriented courtyard space near the northeast corner of the building contains various materials stored uncovered. This may indicate a lack of covered storage space.

*Image: Various building and maintenance materials are stored uncovered in a courtyard space.*

It is recommended that storage needs for building and maintenance materials be evaluated and accommodated in the future scope of work.

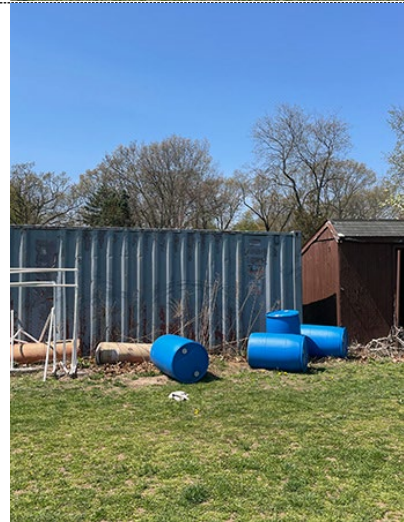
Various materials are stored outside of a trailer and shed within an open lawn area in the northwestern corner of the site.

*Image: Rain barrels and various athletic materials stored uncovered.*

It is recommended that storage needs for athletic materials be evaluated and accommodated in the future scope of work.

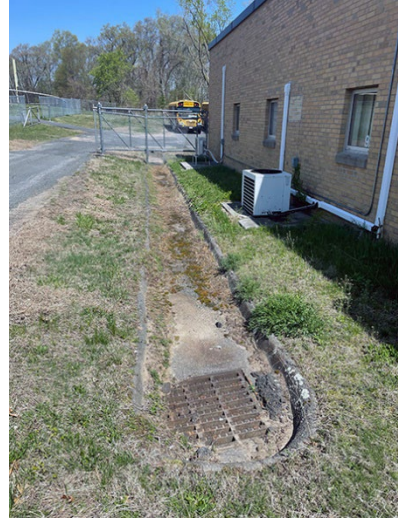
Several landscape drainage features on site (catch basins within asphalt) appear partially compromised by vegetation.

*Image: Asphalt drainage swale encumbered by moss and grasses.*

It is recommended that landscape drainage be restored, potentially using Low Impact Development drainage technologies such as bioswales or rain gardens.

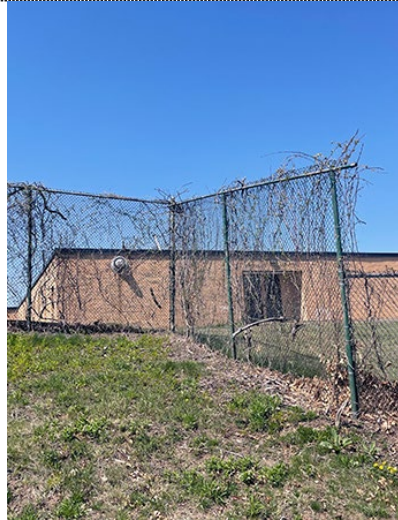
Several site furnishings are in poor condition, including wood benches and picnic tables within the courtyard, the wood compost bins adjacent the courtyard greenhouse, and the chain link perimeter fencing.

*Image: Chain link fence in poor condition near the northeast corner of the school.*

It is recommended that all site furnishings in poor condition be removed. If their function is important to school or community programming, it is recommended that they be replaced.

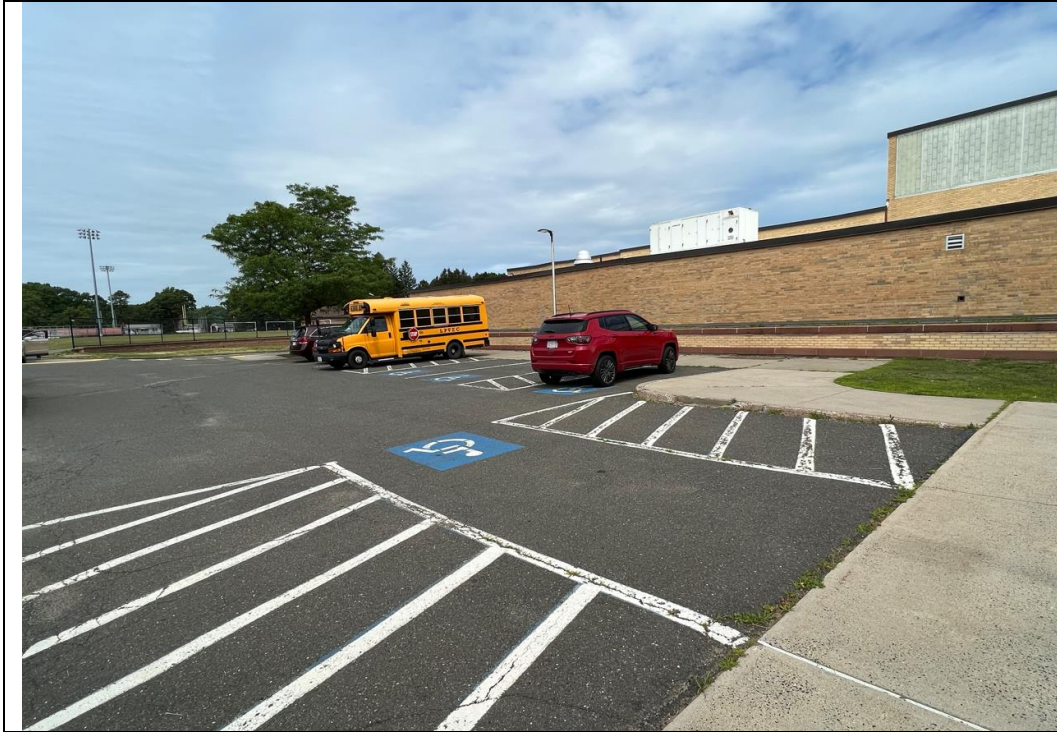
Figure 01: Main parking lot ADA parking area at the northwest corner of the main parking lot. All ADA areas should be checked for ADA compliant slopes and design.

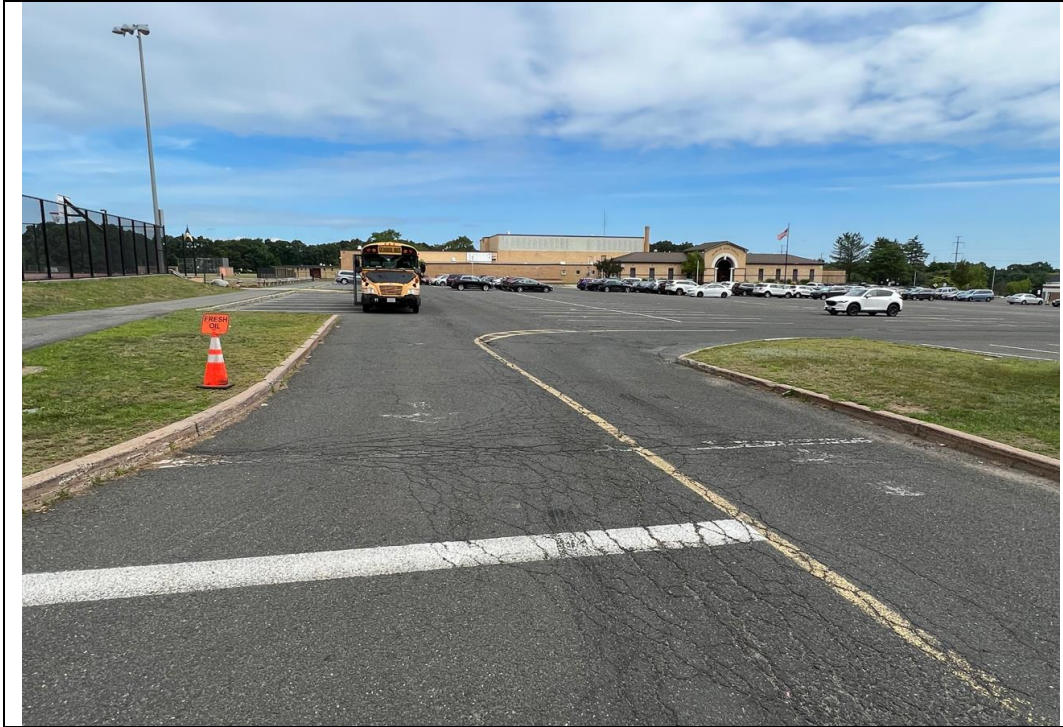
Figure 03: Typical condition of asphalt pavement on the campus, with alligator cracking visible.

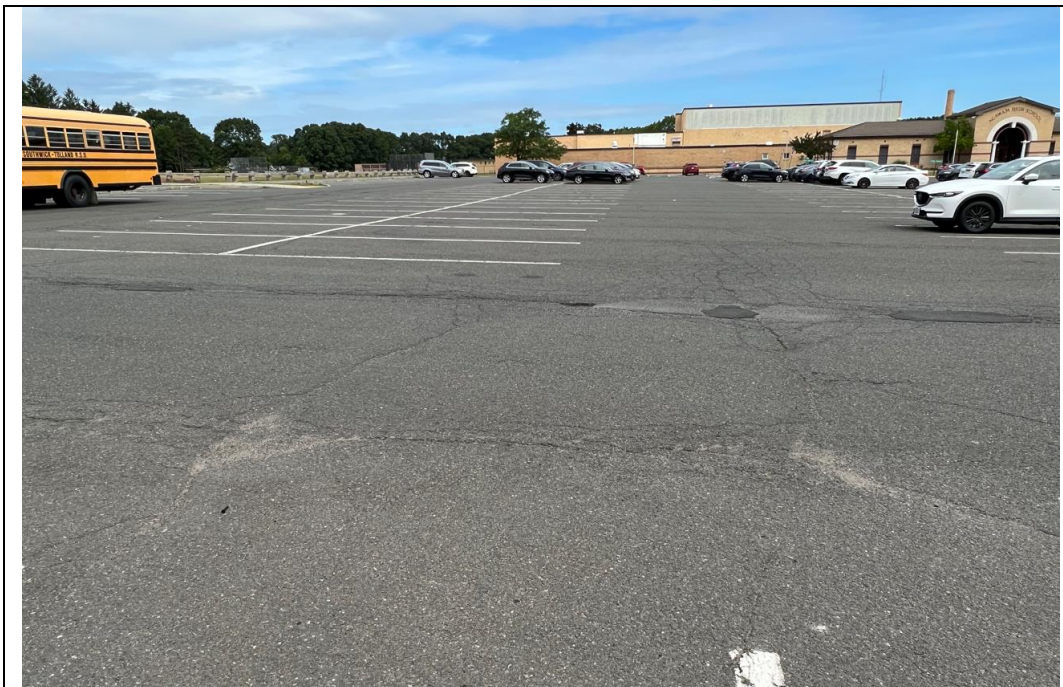
Figure 04: Longitudinal (Linear) and transverse cracking of bituminous paving in primary parking lot, with several patch areas also visible.

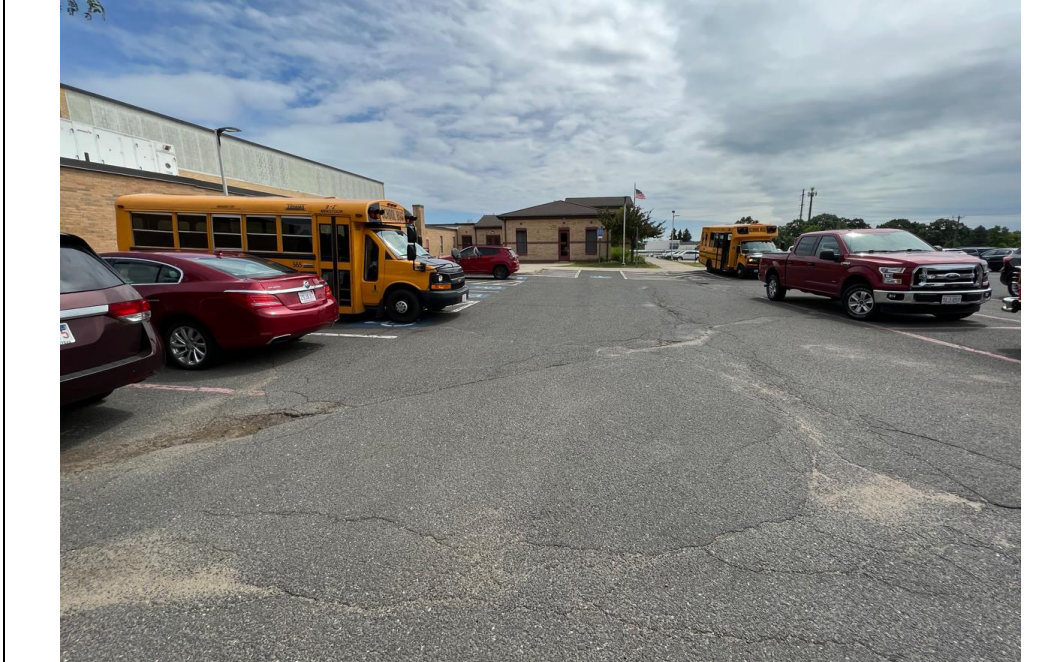
Figure 05: Longitudinal (Linear) and transverse cracking of bituminous paving in primary parking Lot.

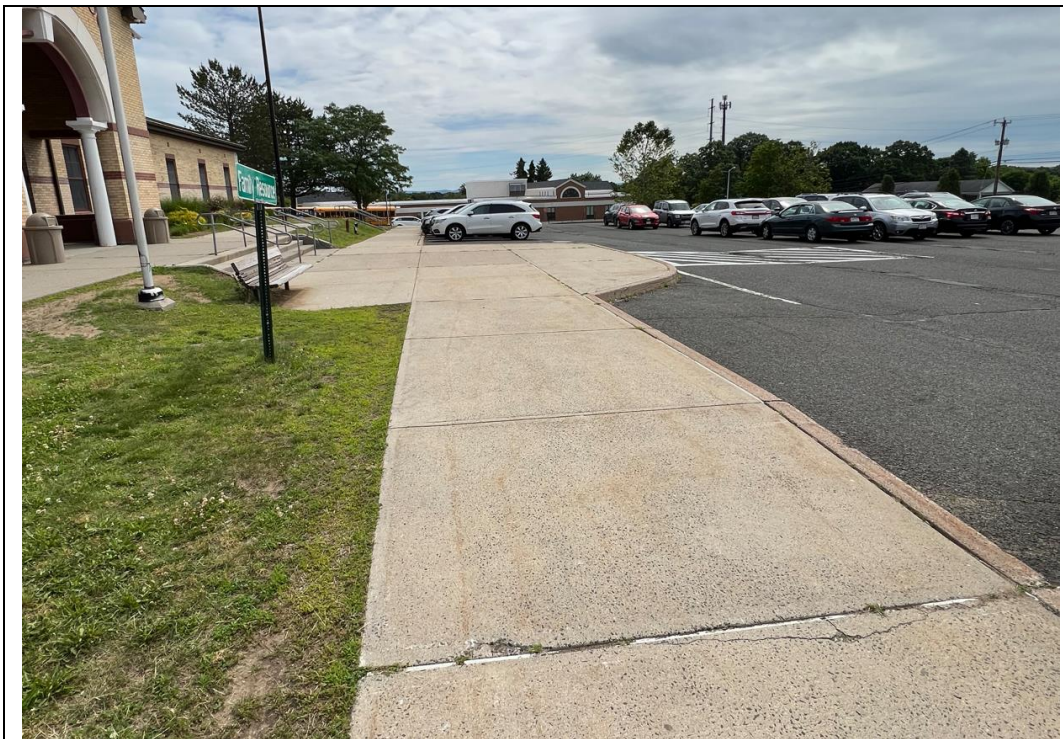
Figure 06: Typical condition of concrete walkways on the campus. Accessible curb cut needed at crosswalk stripping.

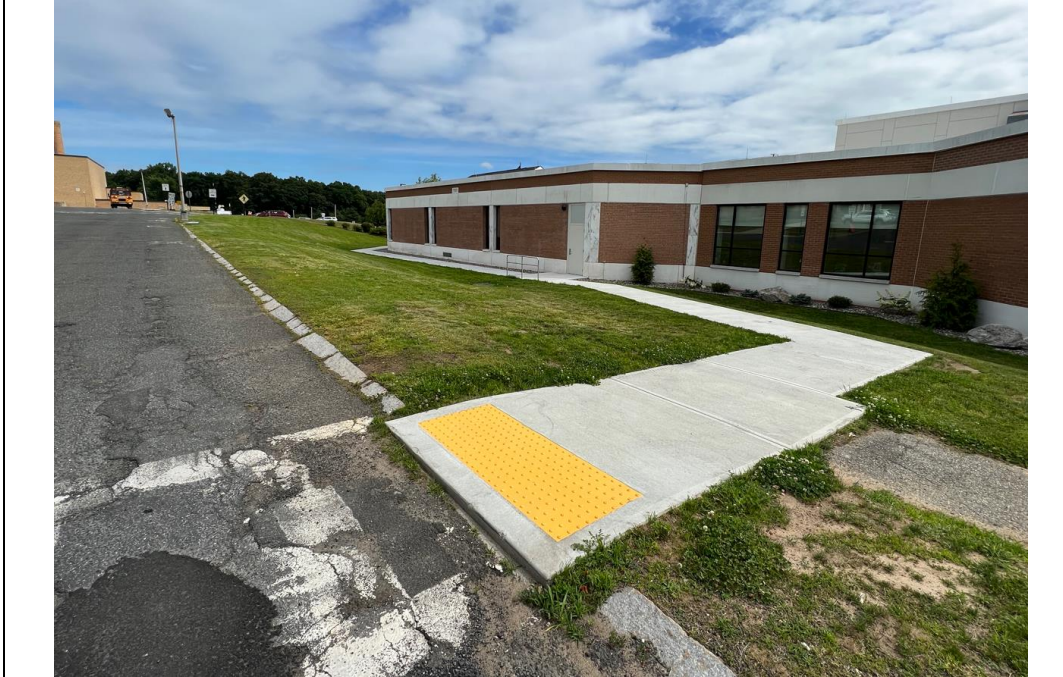
Figure 09: ADA/MAAB non-compliant crosswalk and curb ramps at the library across from the existing high school. The new ADA access should integrate with that existing ADA ramp.

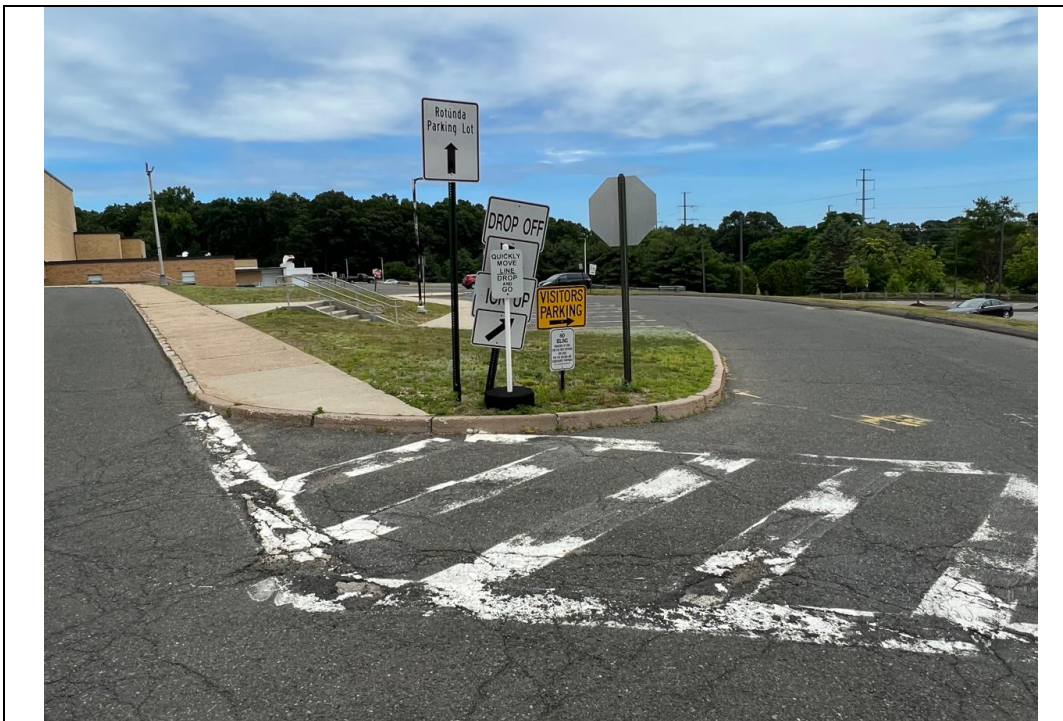
Figure 10: ADA/MAAB non-compliant crosswalk and curb ramps.

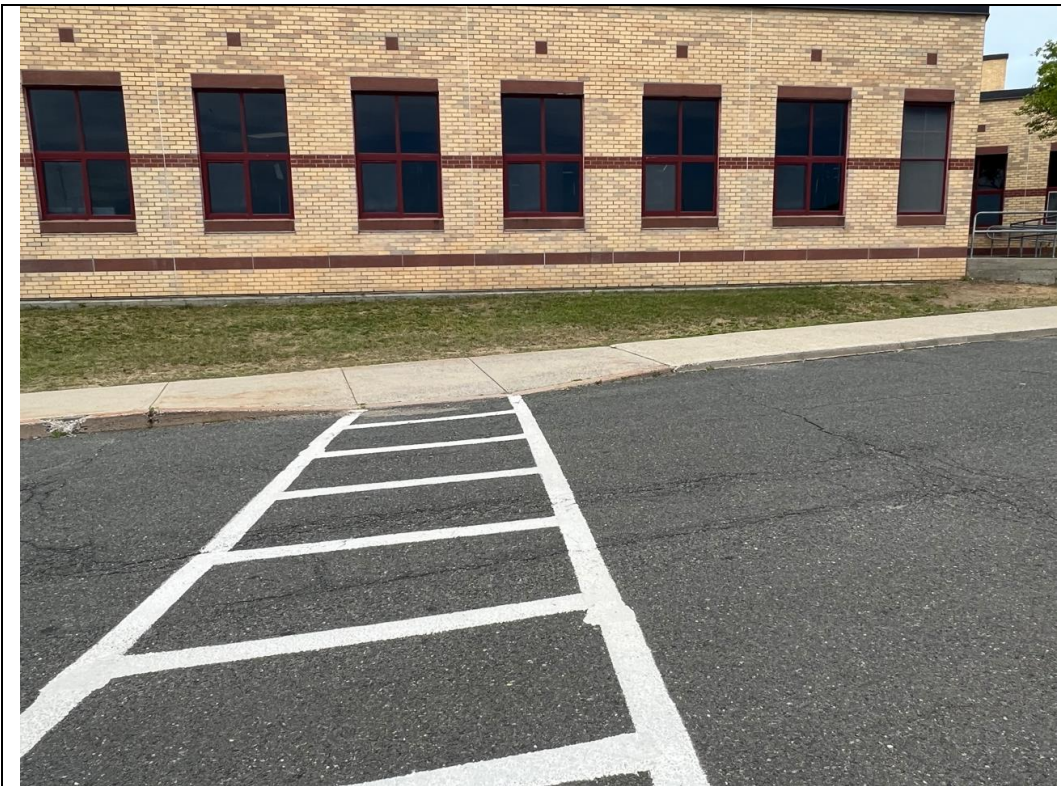
Figure 12: ADA/MAAB non-compliant crosswalk and curb ramps.

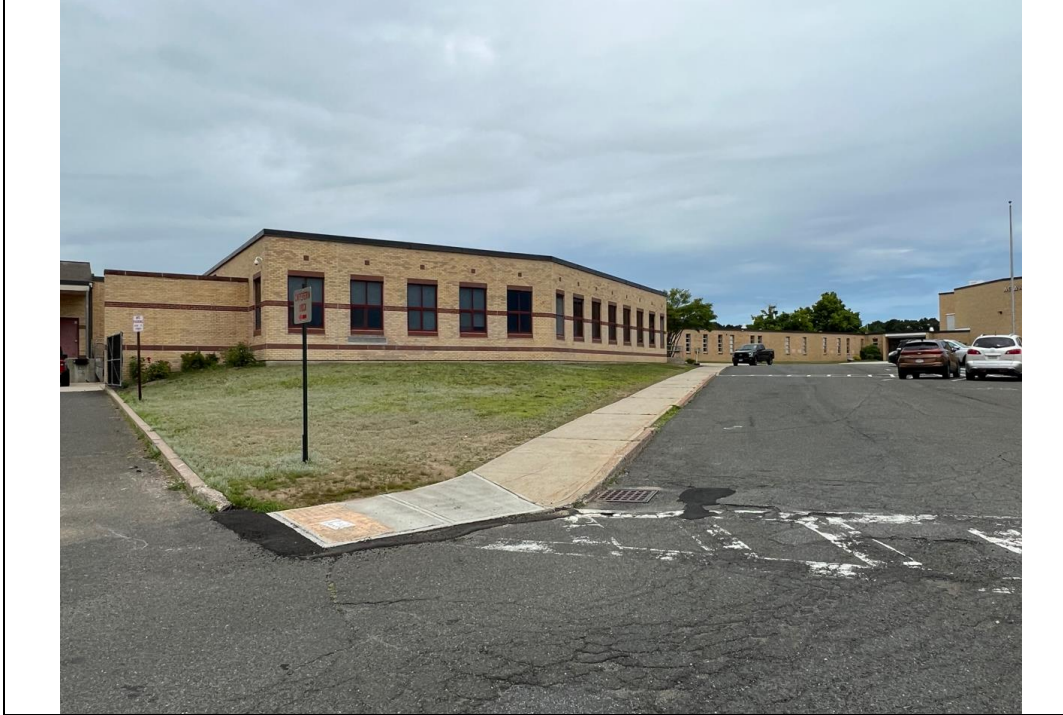
Figure 13: ADA/MAAB non-compliant crosswalk and curb ramps.

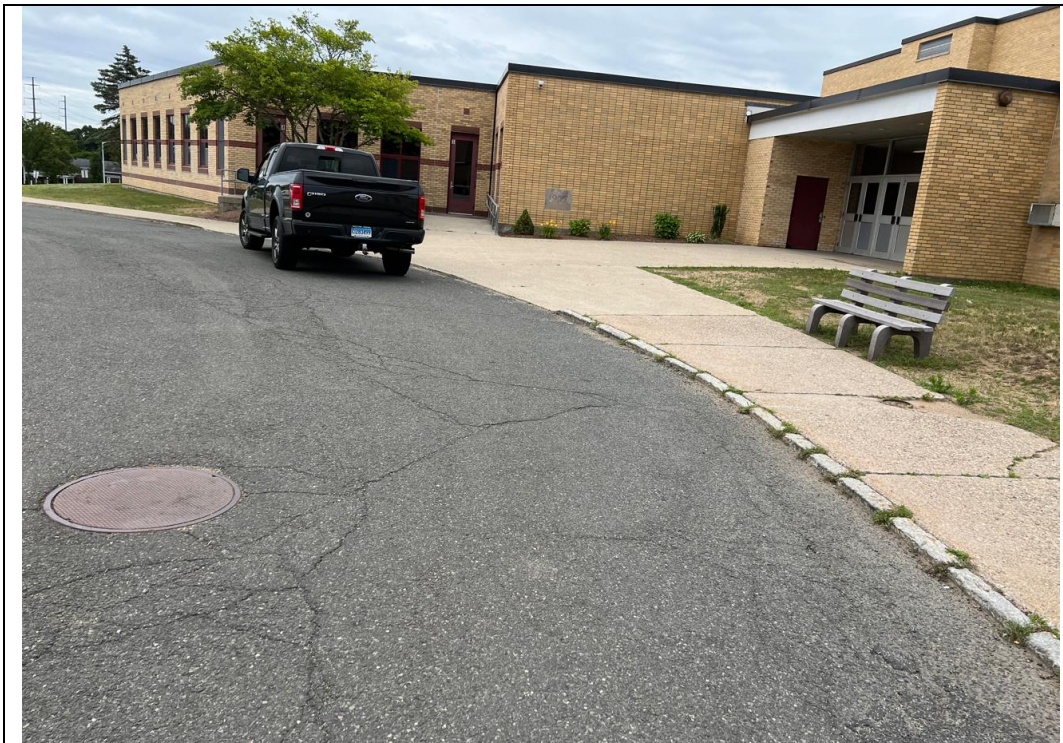
Figure 14: ADA/MAAB non-compliant crosswalk and curb ramps.

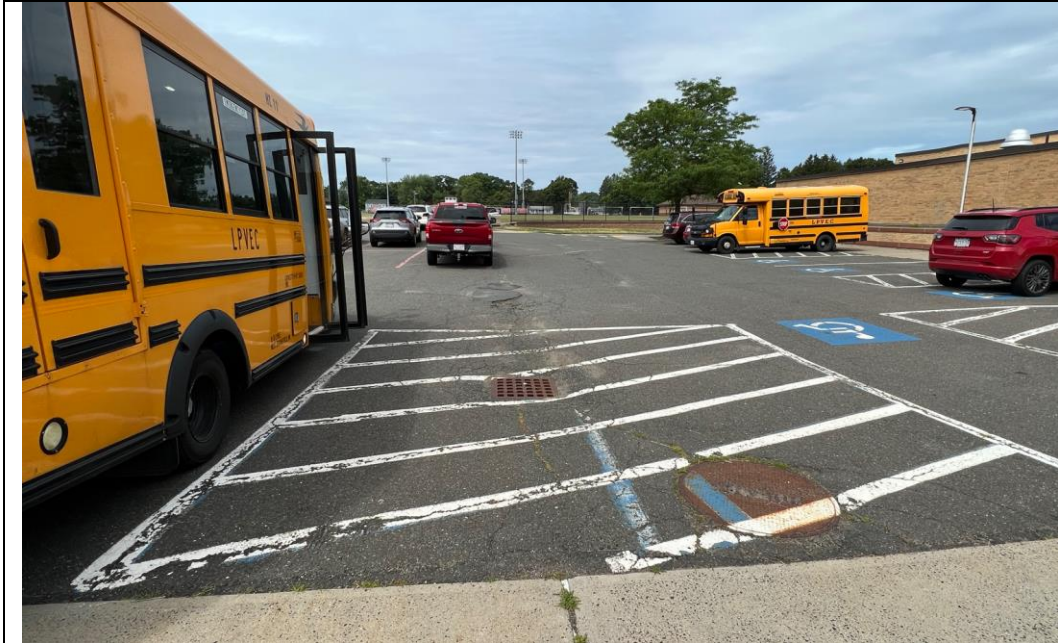
Figure 15: Catch basins in pedestrian areas to be ADA/MAAB compliant

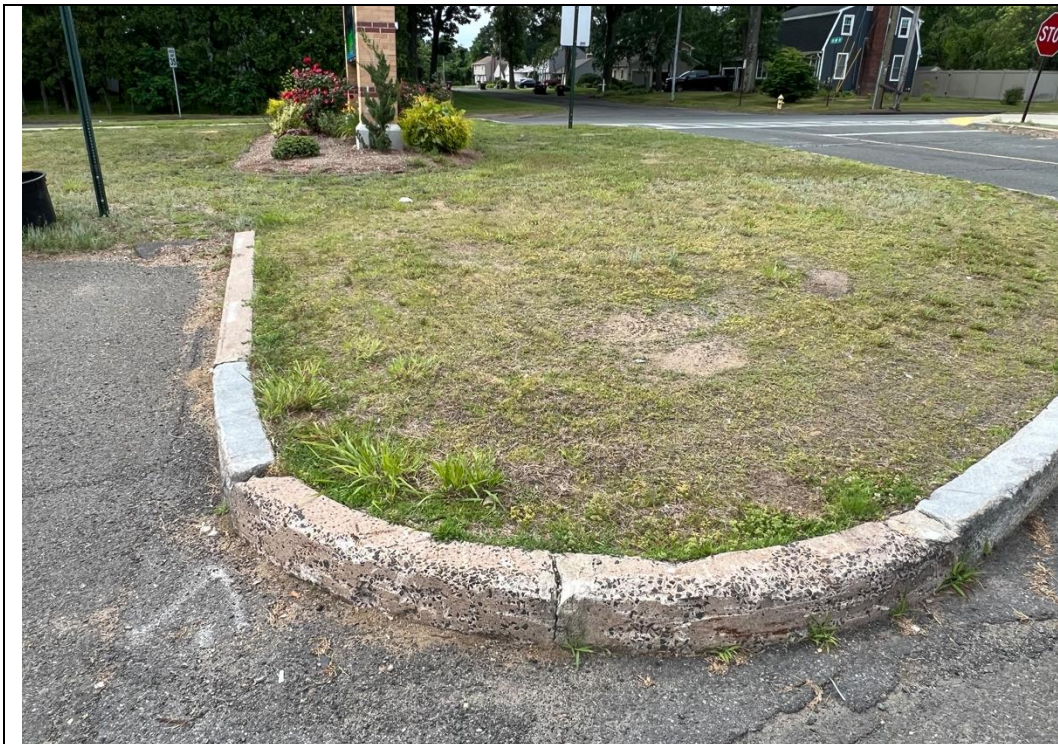
The curbing on site primarily consists of concrete curbing integrated with the existing sidewalks, but some areas of bituminous berms or granite curbing also exist. The concrete curbing is in similar shape as the concrete sidewalks, poor to decent condition with only a few major failure areas noted. The bituminous berms observed were in varying conditions, in some cases completely broken and crumbling (i.e. in the south side of the main parking lot), but in other areas just in fair condition with periodic cracks and gouges noted. The granite curbs were primarily of the sloping variety, and were sinking into the surrounding grade in several places, notably along the Cooper Street drive entrance adjacent to the library. In general, it is recommended that the existing curbing be patched and repaired at a minimum, or replaced where possible, the curbs should be between 4” and 7” high, See Figure 16 below. Utility poles need to be protected in parking areas (see Figure 17)

Figure 16: Typical condition of concrete curbing on the campus, in most cases disjointed and in poor condition.

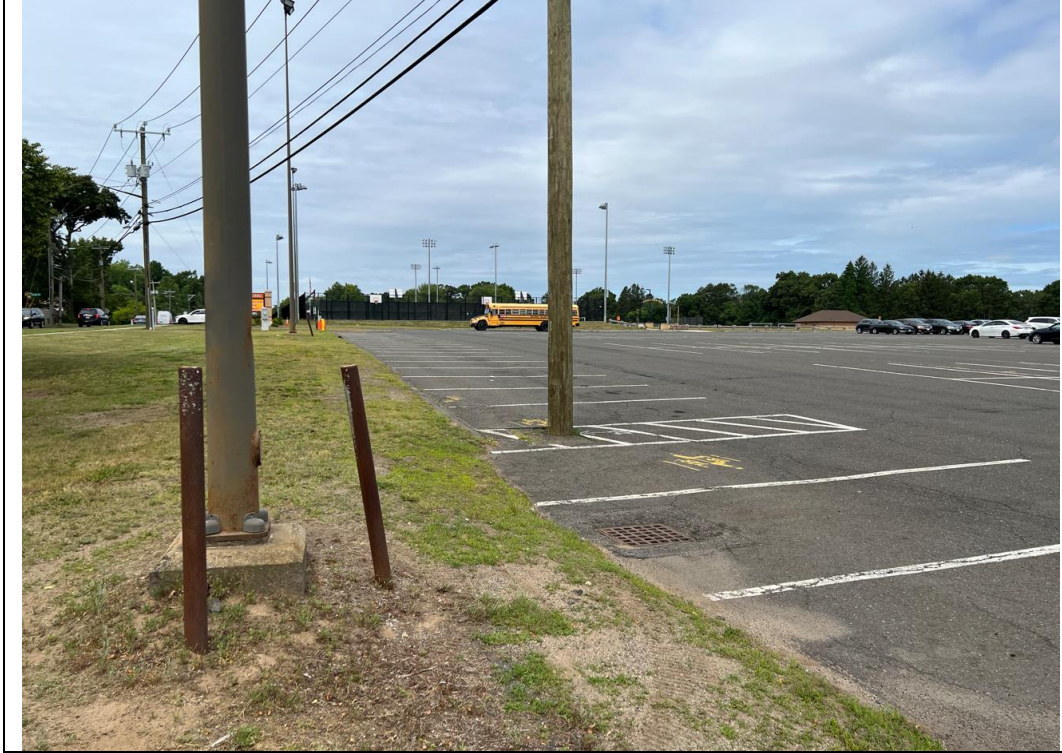
Figure 17: Typical utility poles through parking lot to be protected.

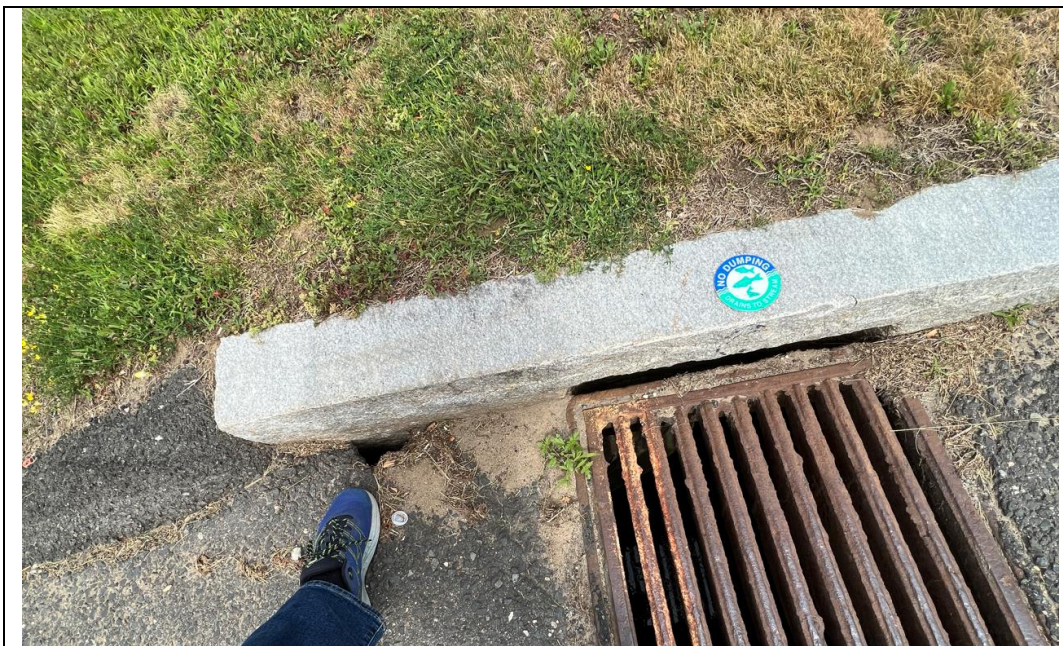
Figure 22: Small sinkhole observed at granite curb next to catch basin.

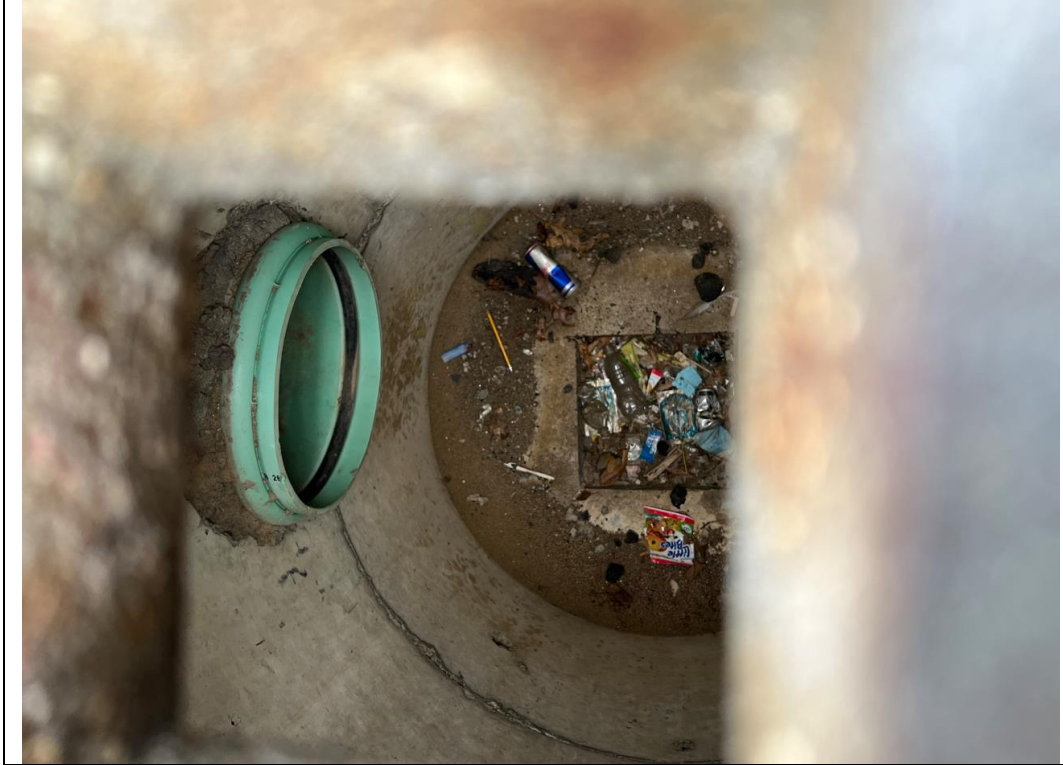
It appears (based on the site visit) that the some of the drainage system is not maintained or cleaned on a regular basis (see Figures 23-25). In particular, the double catch basin in the eastern lower parking lot addition is clearly undersized, with erosion channels having formed from previous stormwater events leading down the slope to the east of the parking are. Stormwater Best Management Practices (BMP's) and Low Impact Design (LID) were not as prevalent during the time period in which the High School was constructed. Due to the age of the system and a lack of Best Management Practices installed at the time of construction, it is recommended that the proposed renovation work also include the improvement of the existing stormwater system on site. In order to determine the feasibility of incorporating updated stormwater management practices, a full cleaning and CCTV condition assessment and report of the existing storm drainage system is recommended to inform future design phases. It is recommended that all structures be cleaned of debris and sediment, and that the eastern lot double catch basin be improved as soon as possible to prevent further erosion.

Figure 23: Catch basin with some debris and sediment.

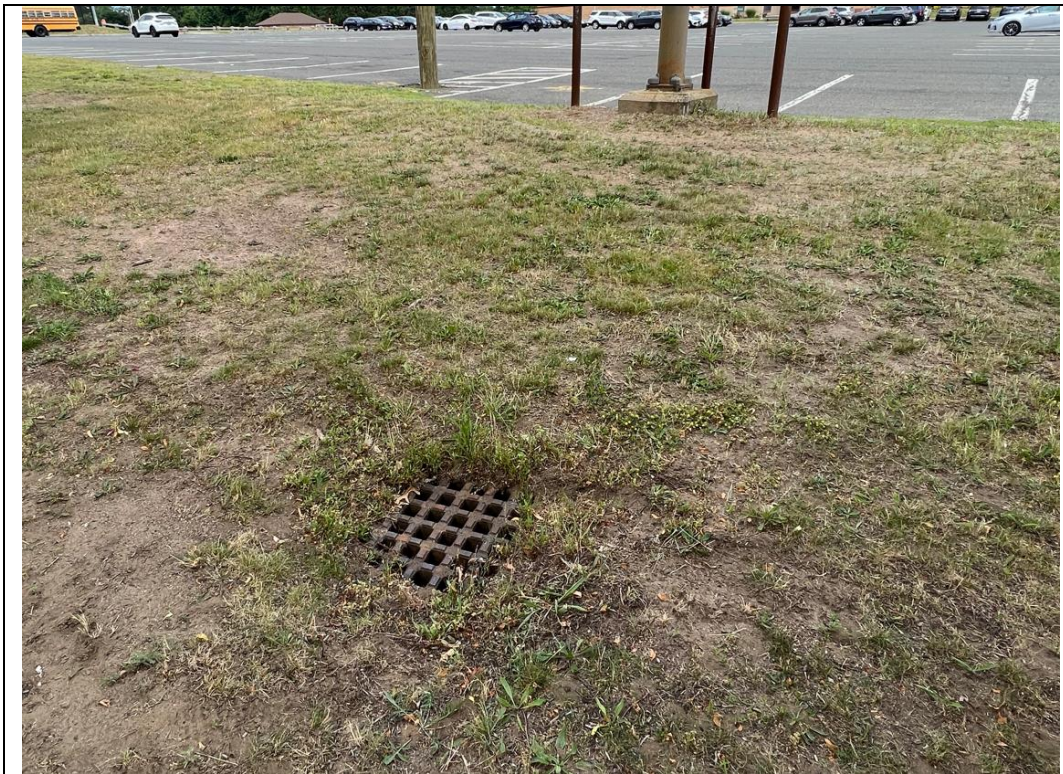
Figure 24: Overgrown catch basin drainage cover.

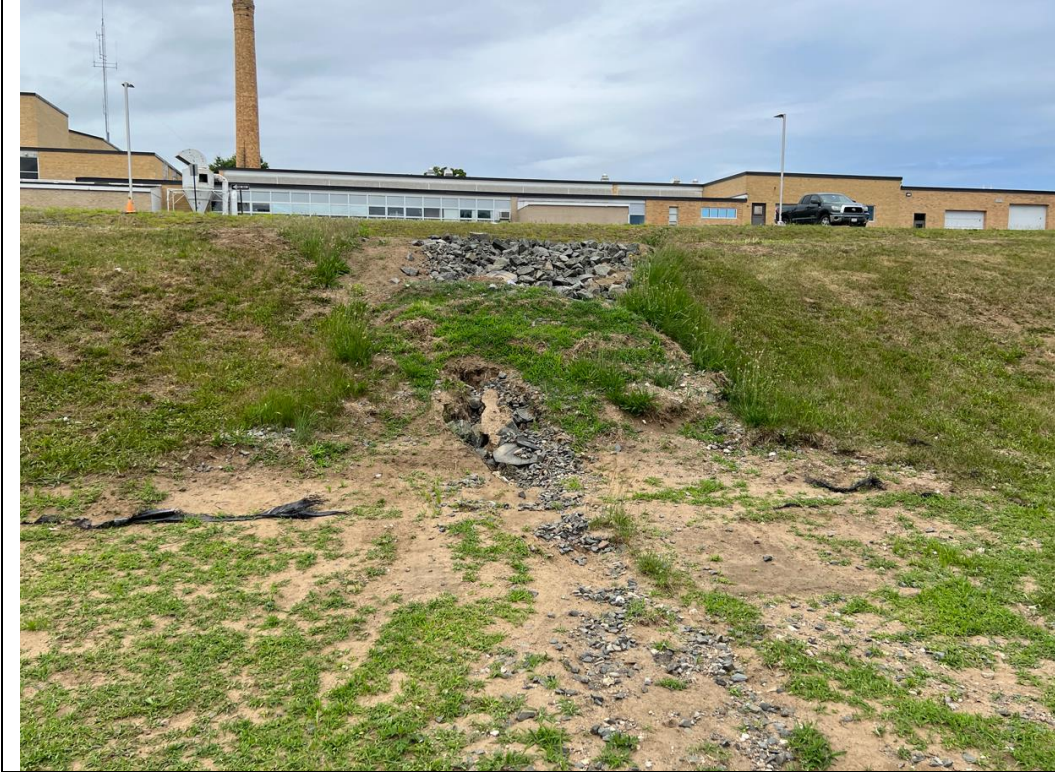
Figure 25: Rip rap at main DCB in the rear parking area, with debris and sediment noted. This area has clearly been a major erosion point and should be addressed with improved drainage infrastructure.
