Agawam High School

Agawam, MA

School Building Committee Meeting #5

May 8, 2023

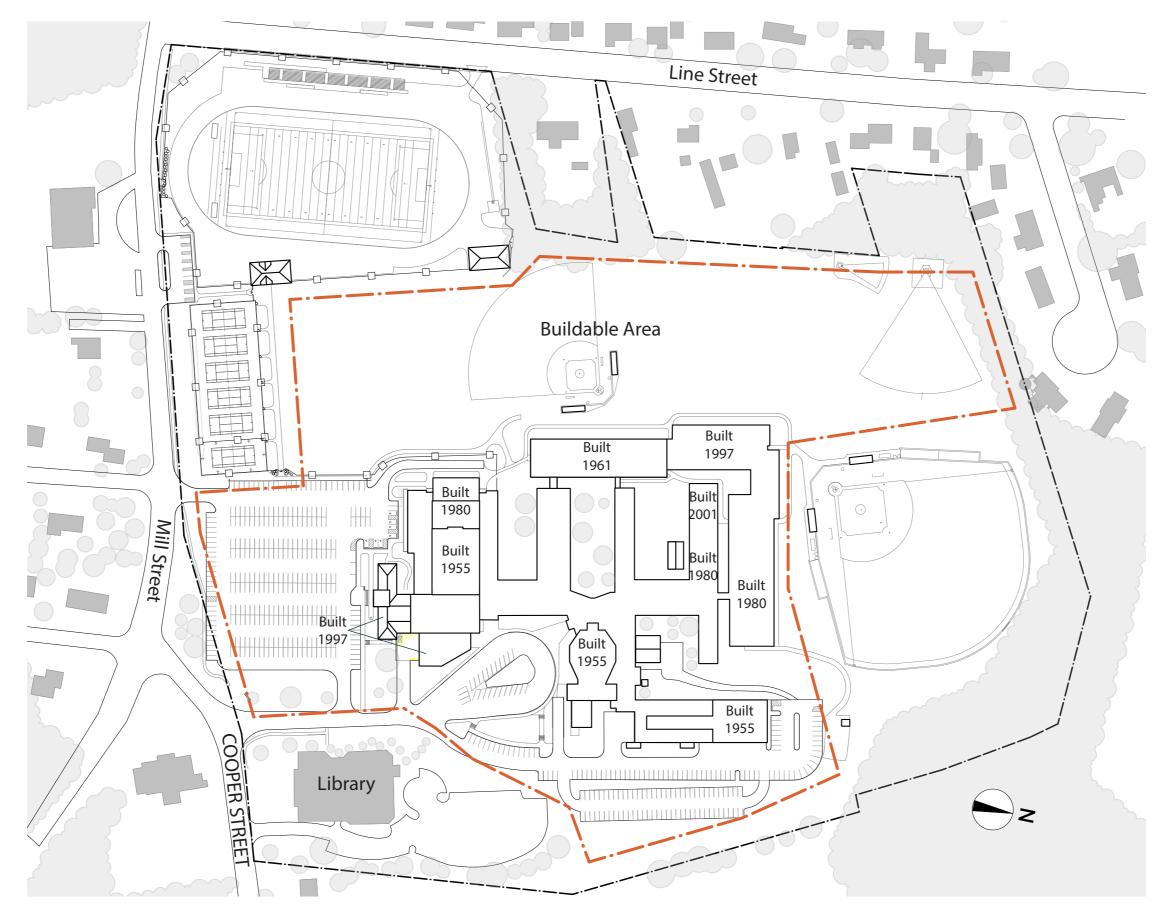
Site Plan

Buildable Area: 23.38 Acres

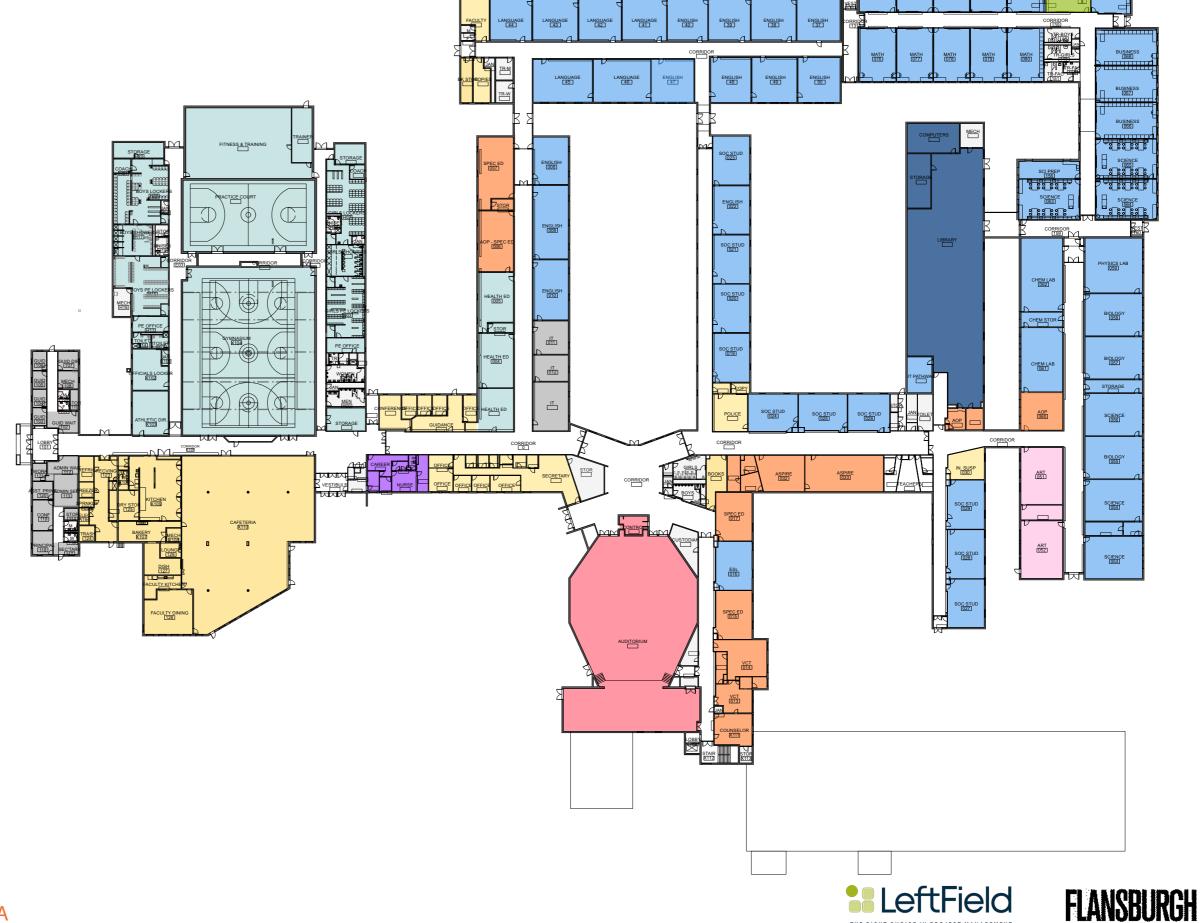
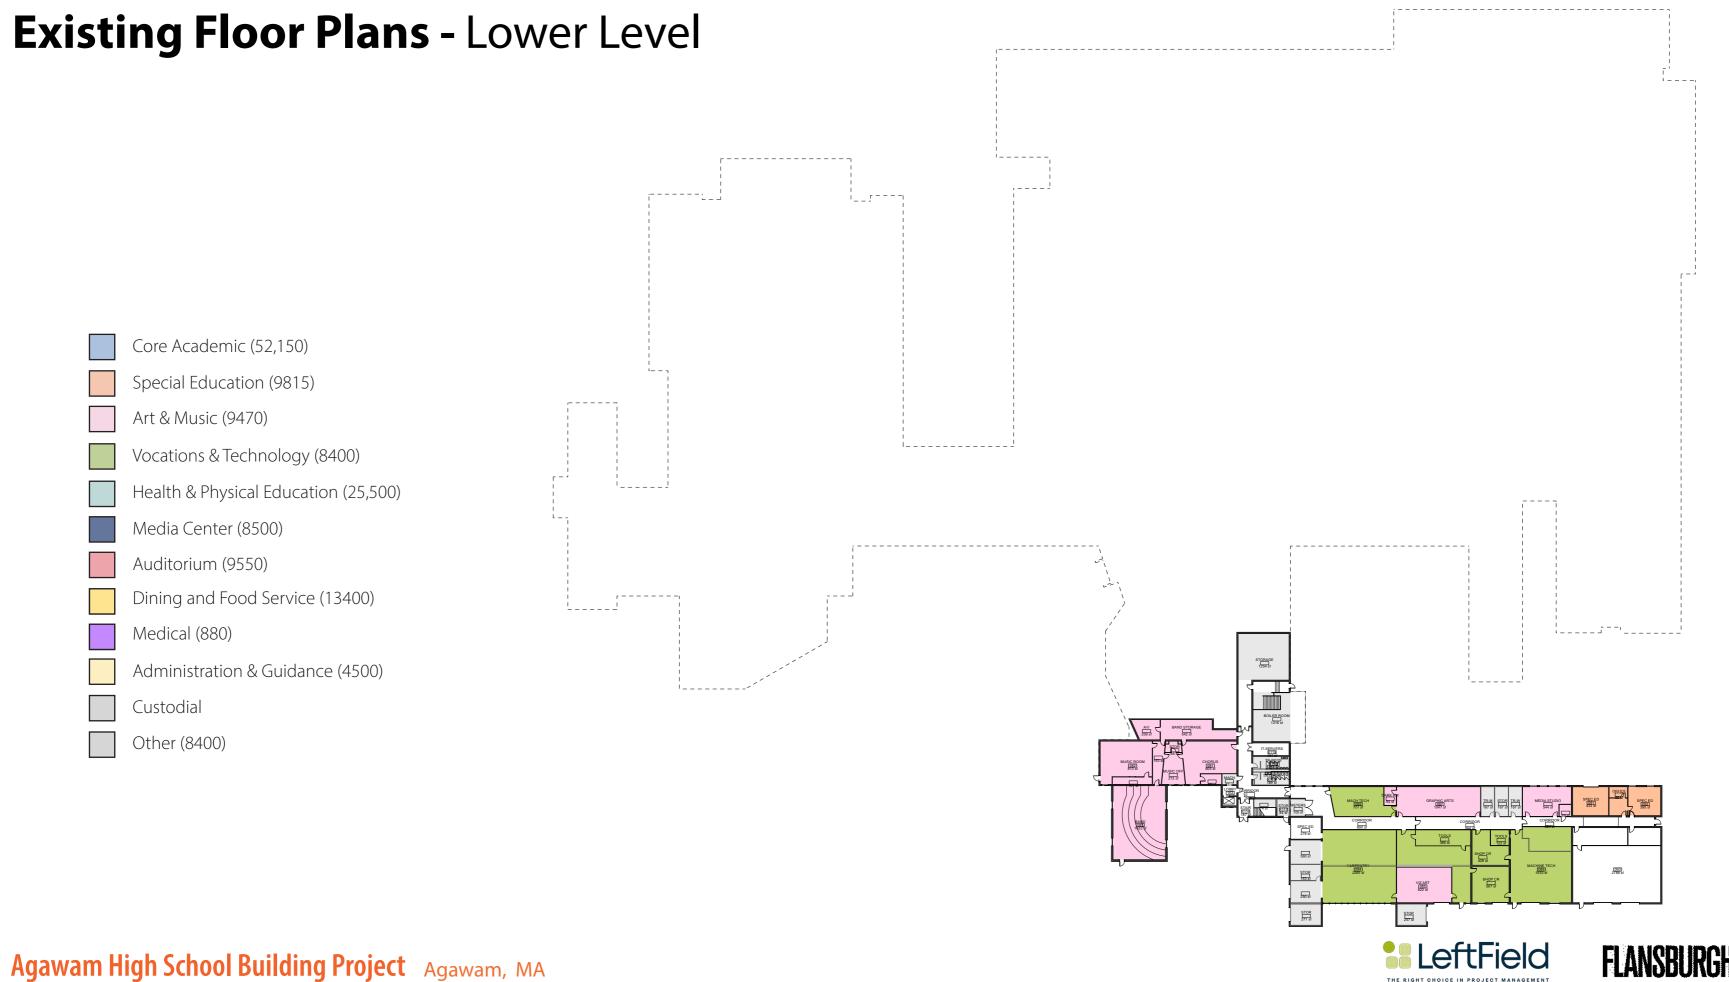
Existing Floor Plans - Upper Level

Special Education (9815)

Art & Music (9470)

Vocations & Technology (8400)

Health & Physical Education (25,500)

Media Center (8500)

Auditorium (9550)

Dining and Food Service (13400)

Medical (880)

Administration & Guidance (4500)

Custodial

Other (8400)

Total Net 160,000 Total Gross 216,000

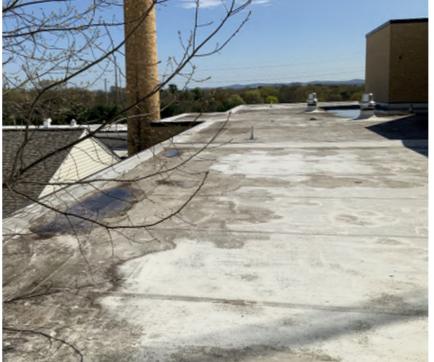
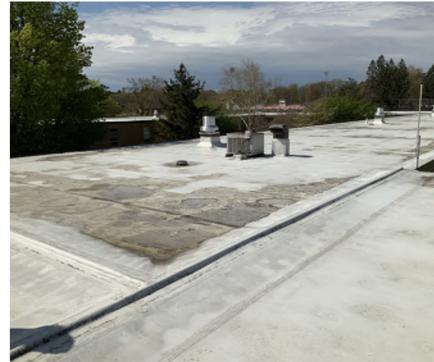
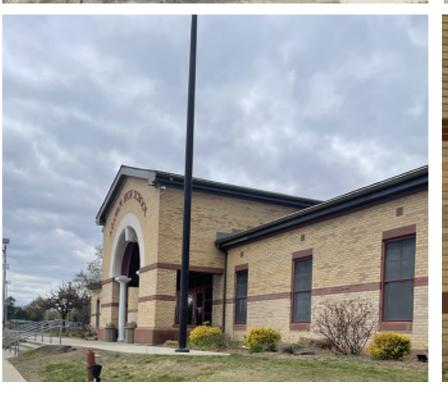
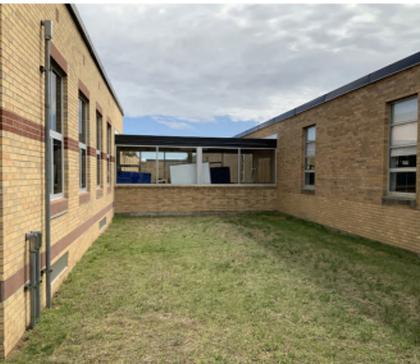
Existing Conditions- Architecture Exterior

- The exterior envelope requires thermal upgrades to be code compliant. This would involve replacing windows, doors, roof and exterior veneer in most locations.
- Multiple exterior doors create security concerns
- Courtyard doors swing in opposite direction for safe egressing.

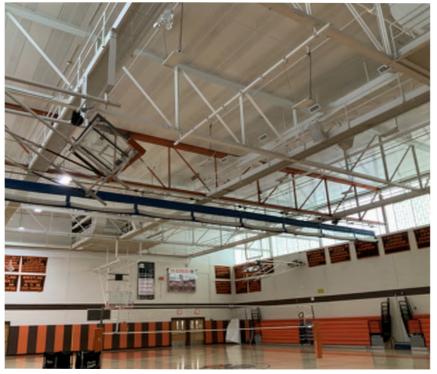
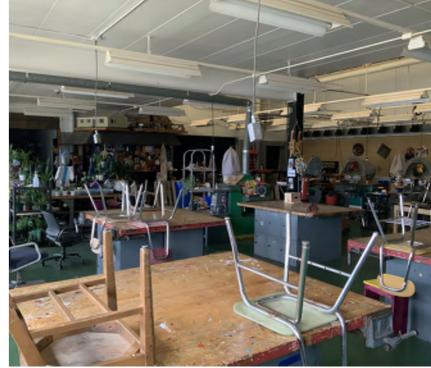
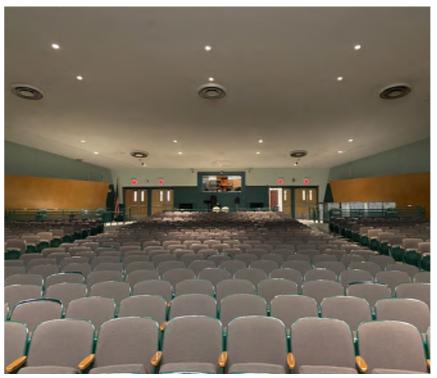
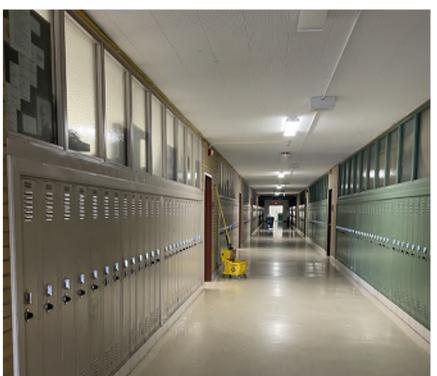
Existing Conditions- Architecture Interior

- Many internal elevation changes with noncompliant ramps.
- Hallways are long and convoluted with long travel times between classes and heavy circulation build up.
- Main entrance is difficult to find for visitors and lacks sense of arrival.
- Limited meeting and collaboration spaces.

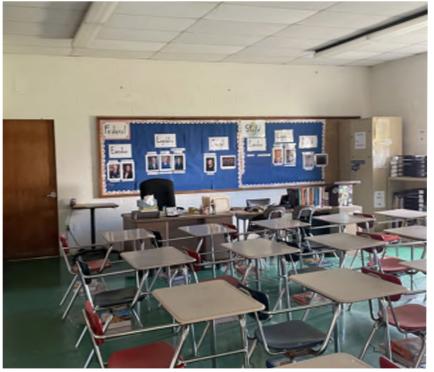
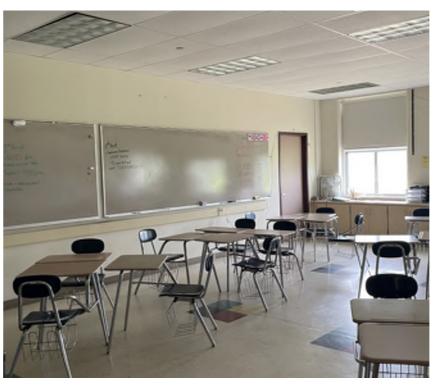
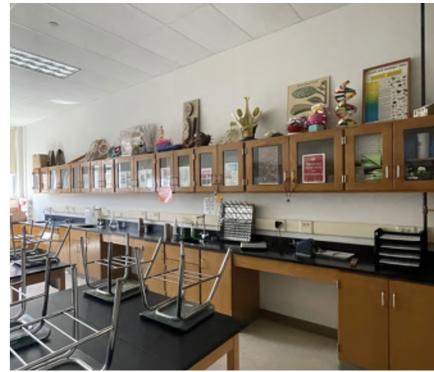
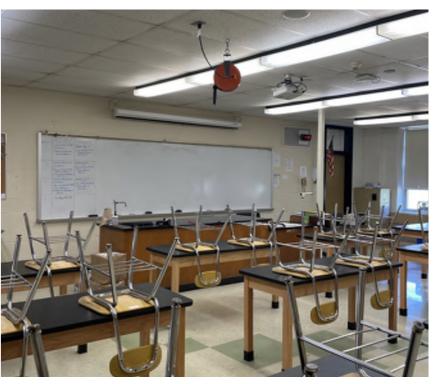
Existing Conditions- Core Academic & Special Eduation

- Classrooms do not meet state standards.
- Special Education spaces are not conducive for serving students. Lower level spaces are disconnected from other learning spaces and the majority of general population at first floor.
- Science lab spaces do not meet OSHA requirements and are not flexible.
- Chemical storage requires proper ventilated cabinets with electrical panels within the space corroding.

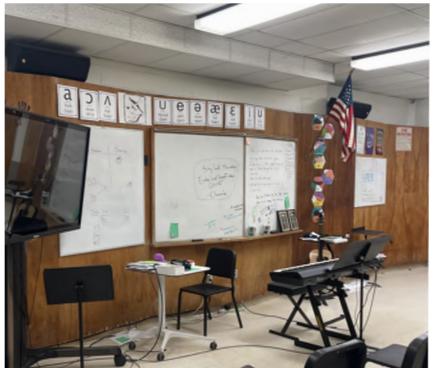
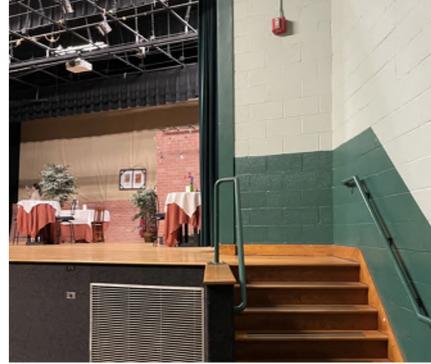
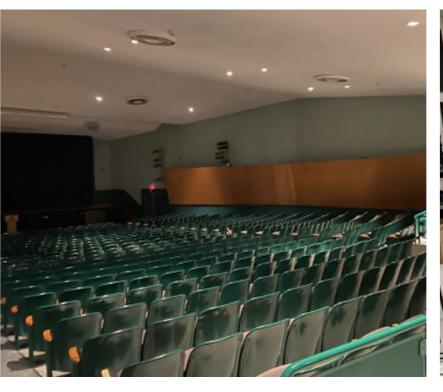
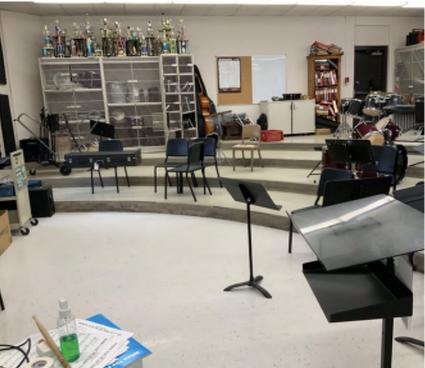
Existing Conditions- Performing Arts

- Band, chorus and Auditorium lacks acoustic balance within spaces and isolation from adjacent spaces.
- The stage house does not have proper height to "fly" stage scenes typical for high school productions.
- The stage does not have ADA accessibility from main house.

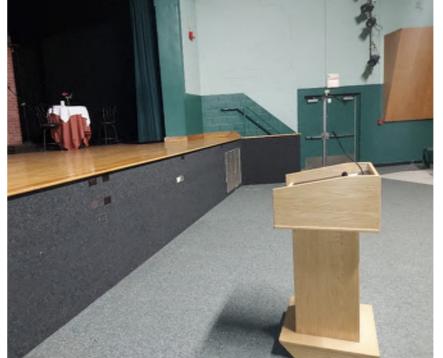
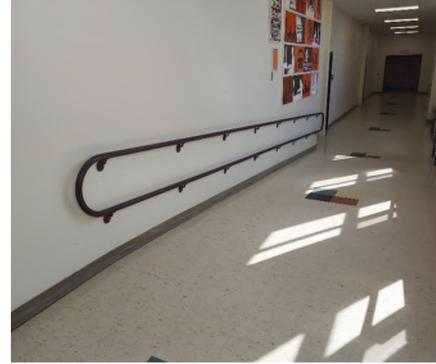
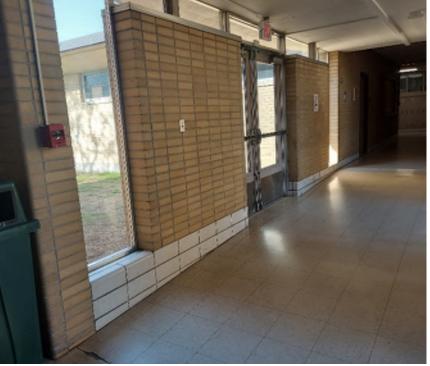
Existing Conditions- Code

- Generally, only the north west portion of the room contains accessible toilets.
- No accessible route to the platform in the auditorium.
- Handrails at ramps do not extend the proper amount and some ramps do not have handrails at all. Ramps exceed the slope limit of 8.2%
- Stairs and handrails generally not compliant.
- Majority of doors are not accessible due to the lack of maneuvering clearances.
- Generally, seating/workstations meet accessibility requirements with the exception of older science labs.
- Water fountains meet accessibility requirements.

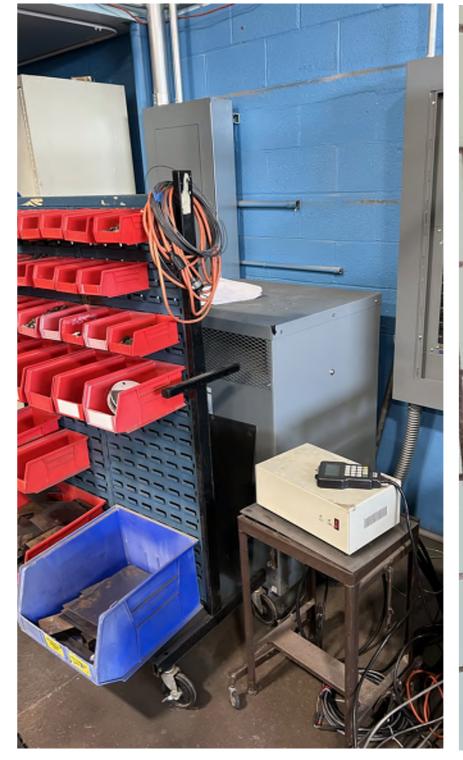
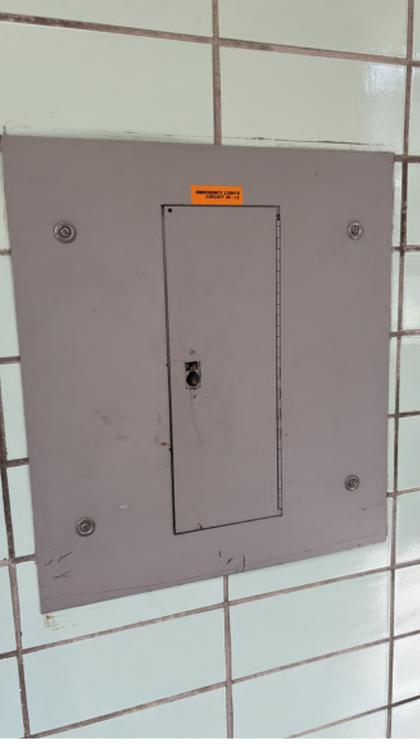
Existing Conditions- Electric

- Mix of original and mid-90's electrical distribution equipment far exceeding or at end of useful life.
- Some corrosion at panelboards; electrical access impeded by storage
- Power in classrooms may be insufficient for today's needs (laptops, online collaboration)
- No emergency power available
- Fluorescent lighting should be replaced with LED for energy savings

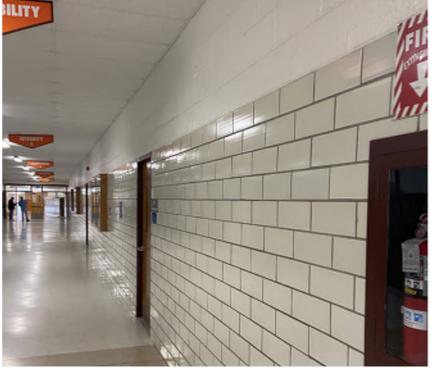
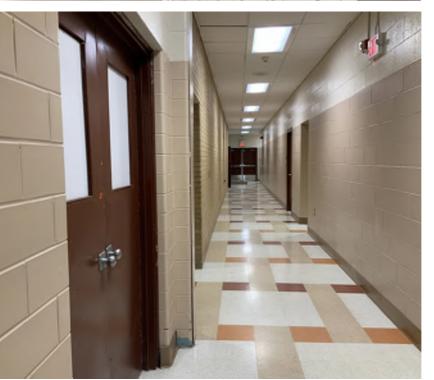
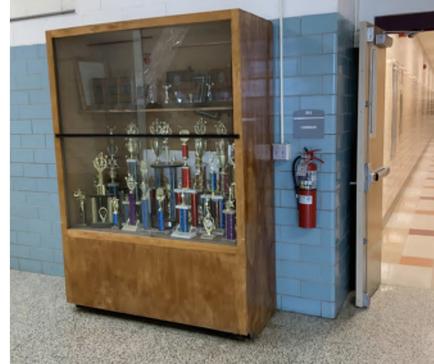
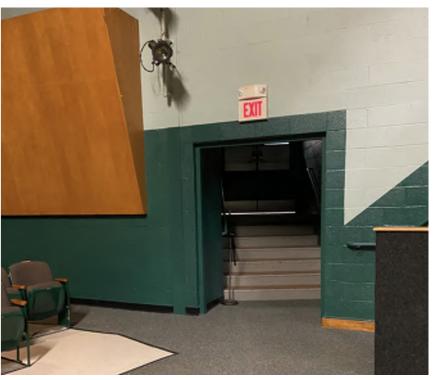
Existing Conditions- Fire Alarm and Fire Protection

- Edwards Fire Alarm Control Panel from mid-90's at end of useful life
- Detection and notification systems throughout system not compliant with current code (coverage)
- Any major renovations or new construction will require a fully sprinklered building according to NFPA 13-2019
- Partial sprinkler system in north part of building, covering classroom, science prep/storage rooms, hallways, janitor closets and restrooms.
- Partial sprinkler system in south part of building covering offices with hallways, partial cafeteria, dishwashing, mechanical and maintenance spaces.

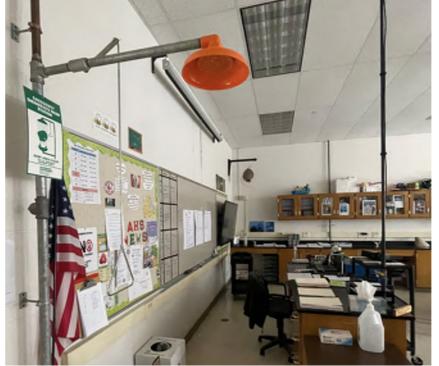
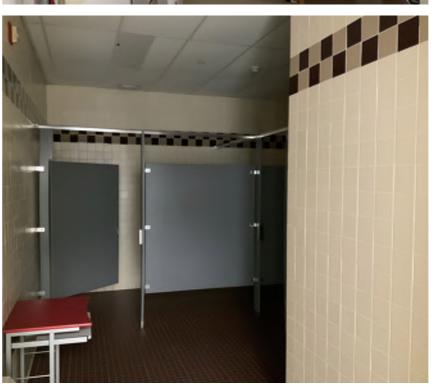
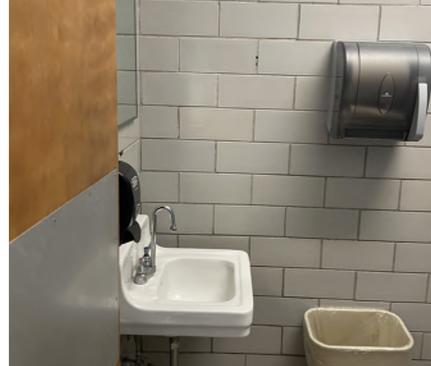
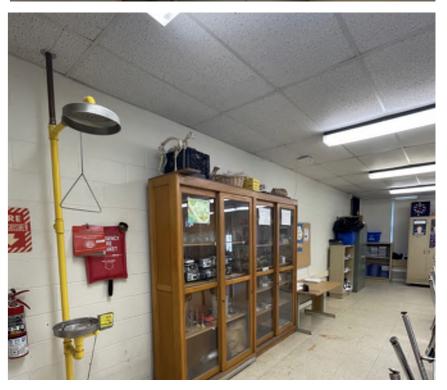
Existing Conditions- Plumbing

- All waste, vent, and water piping should be considered, due to the age of the building. The piping is original to the building
- About 80% of the fixtures throughout the building are from original construction and not as efficient as new fixtures would be.
- The locker rooms and associated areas were renovated in 2018 with some high-efficiency fixtures.
- Point-of-use storage type electric water heaters are located throughout the building.
- The science classrooms where fume hoods and gas/ water science tables are used have a monitoring system that is not code compliant.

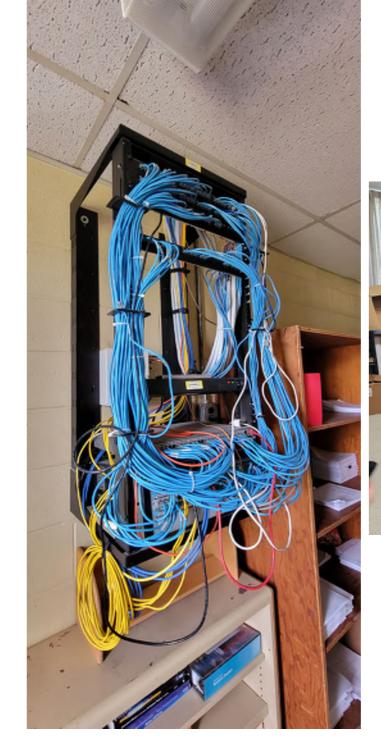
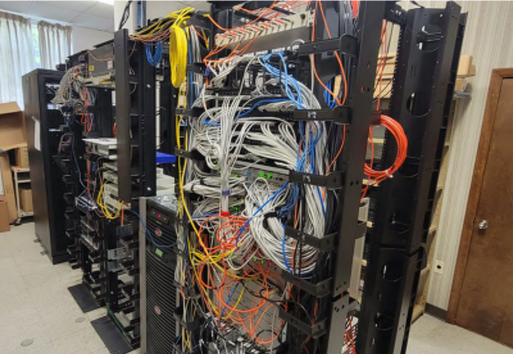
Existing Conditions- Telecom

- No dedicated cooling equipment may become overheated
- Daisy chain topology single point of failure
- Uninterruptible Power Supply not in use
- Lack of cable management, cables abandoned in place and no system labeling - space constraints and maintenance difficulties

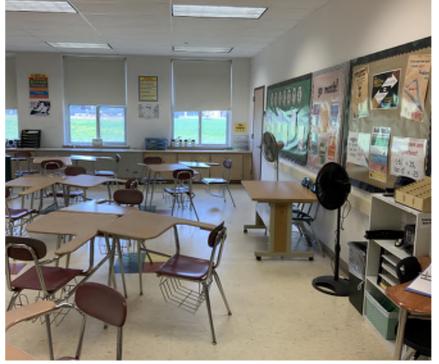
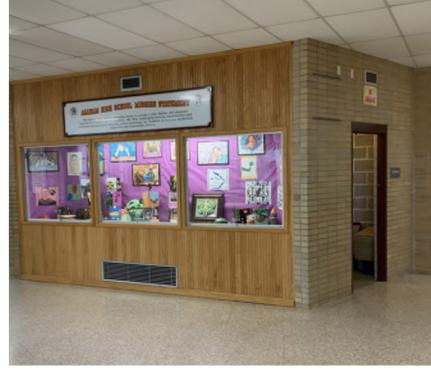
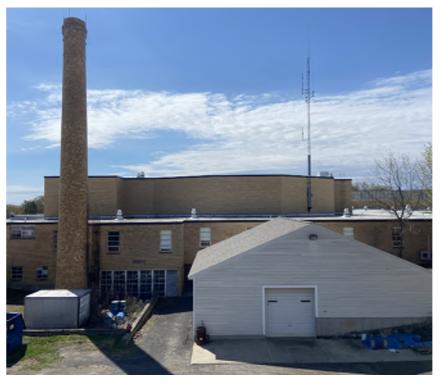
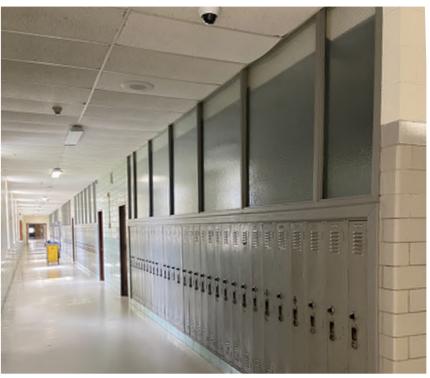
Existing Conditions- Building Findings Summary

- The existing school structure is in fair condition
- We did not observe any signs of foundation settlement
- We did not observe any positive connections between the non-structural masonry partition walls and the structure
- Observed damage from moisture at the base of the exterior door frames at same locations.
- It is not feasible to construct vertical additions on top of existing structure
- If the extents of renovations is extensive, that is if the Work Area is greater than 50% of the gross area of the building. (Level 3 Alterations), we will have to add new masonry shear walls at column lines with new foundations
- We will require that all existing masonry walls are connected to existing structure if the renovations are classified as Level 3 Alterations

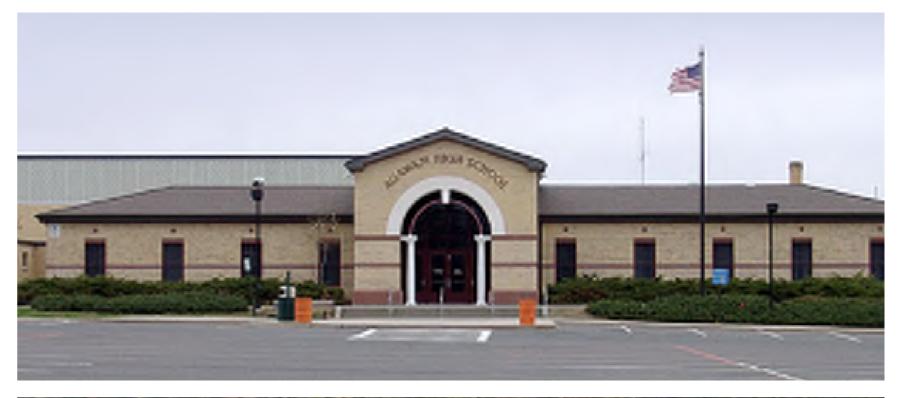
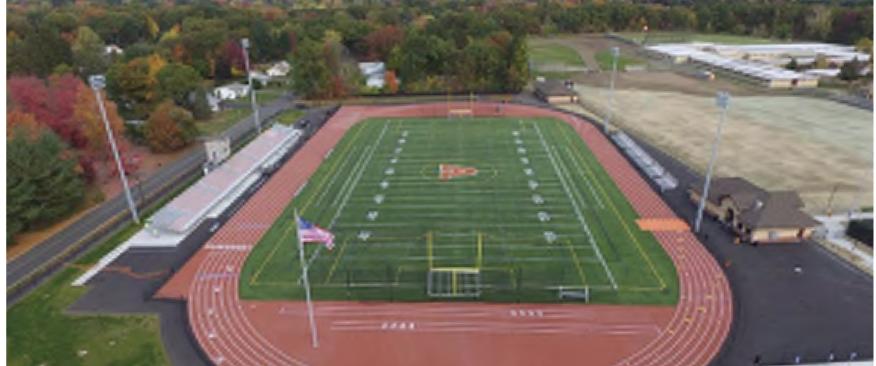
Existing Conditions- Lanscape, Site & Amenities

- Various concrete curbs were observed to be crumbling and in need of repair or replacement.
- The concrete stairs at the main entrance to the school are beginning to crumble, especially surrounding handrail posts.
- Access from the bus parking area up to the sports field brings the visitor up a significantly steep slope that may need further evaluation to meet ADA access requirements.

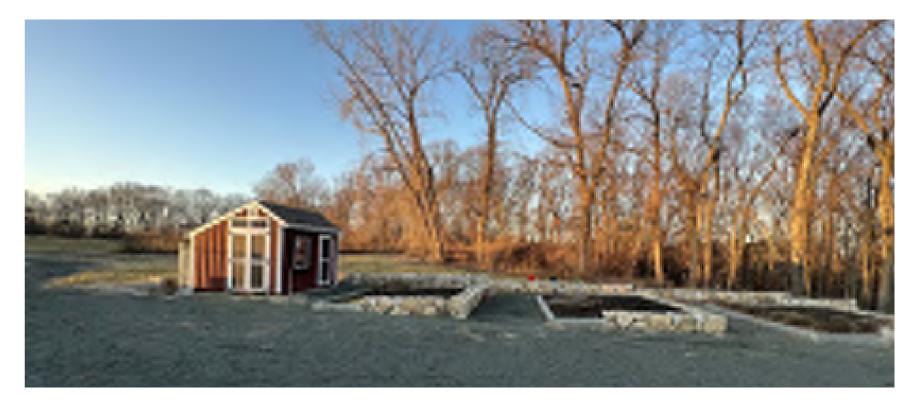
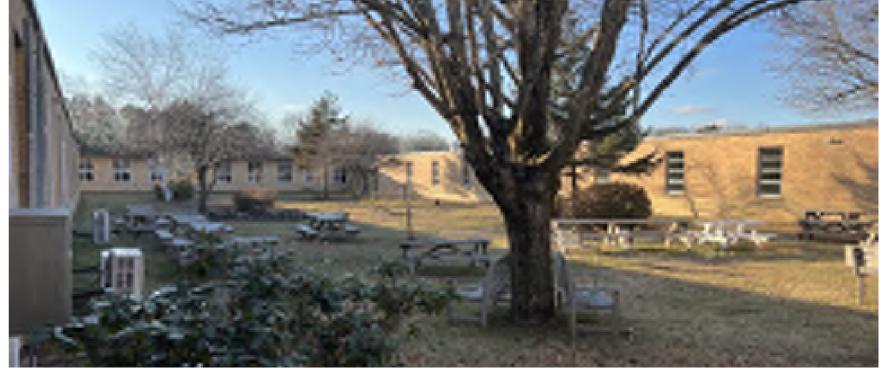
Existing Conditions- Vegetation and Site Furnishings

- The site is not densely vegetated, but rather selectively sprinkled with mature deciduous trees; the species observed included; Acer (Maple), Quercus (Oak), and Robinia (Locust).
- As mentioned previously, one courtyard was planted with a mix of flowering trees; one tree was planted as a Memorial element for a prior student.
- Ornamental trees, shrubs, and perennials are located at the front facade of each Main Entrance.
- Ornamental boulders with plaques and engravings serve as signage elements and dedications at the entrance to the stadium (from the parking lot) and at the faculty entrance (a Veteran's Memorial).
